# Riverbed Scour Induced by Bridge Destruction

MIODRAG JOVANOVIĆ, *University of Belgrade, Faculty of Civil Engineering*, [mjovanov@grf.bg.ac.yu](mailto:mjovanov@grf.bg.ac.yu)

RADIVOJE JONIC, SINISA SPEGAR, LJUBISA MIHAJLOVIC, *Federal Agency for Development & Maintenance of Inland Waterways, Belgrade, Yugoslavia*, [office@ploput.co.yu](mailto:office@ploput.co.yu)

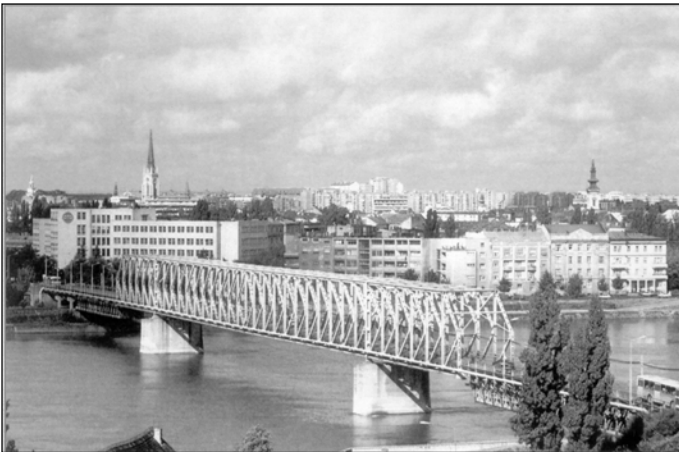
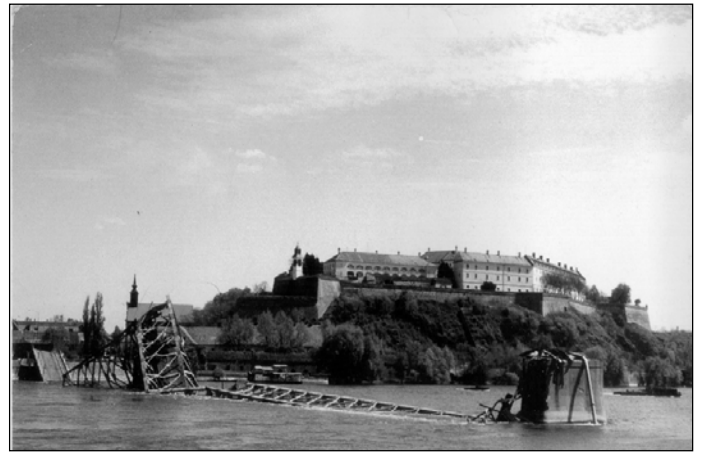
Fig. 2. The Petrovaradin bridge (km 1255) before destruction (on the left), and after destruction (on the right); its structure was K-type girder truss, with the central span of 130 m, and two minor spans 51 m.

Figures 1-3 depict the three bridges on the Danube in the city of Novi Sad (km 1252.90-1258.70), prior and after their destruction in April 1999. These bridges were of different types - suspension prestressed concrete, girder truss steel structure, and massive prestressed concrete arch structure. One consequence of their destruction was that the hydraulic engineers (however unfortunately) got a chance to study local scouring processes in a 1:1 field experiment.

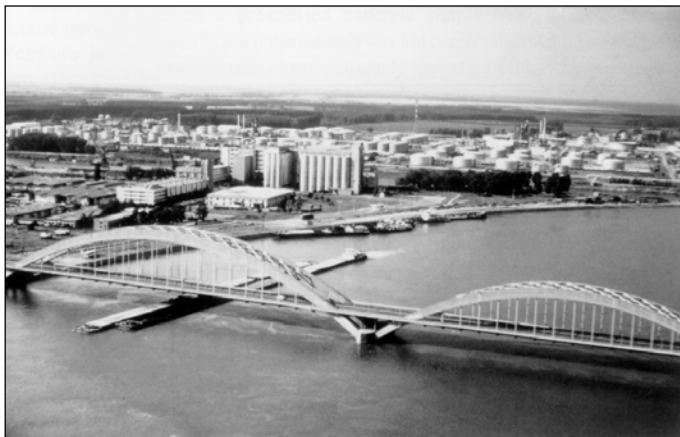
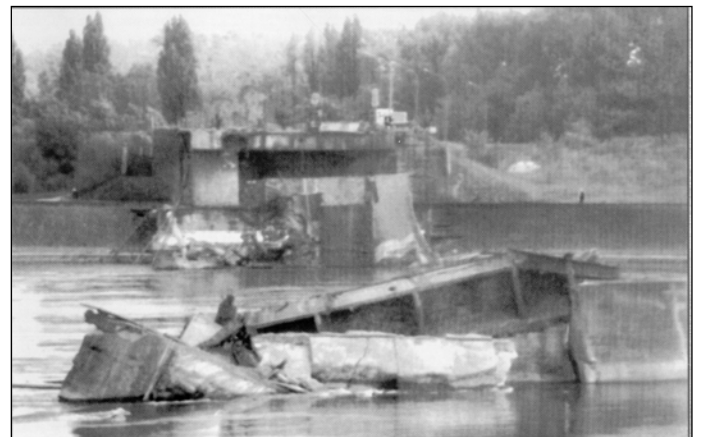
Fig. 3. The Zezelj bridge (km 1254.17) prior to destruction on April 26<sup>th</sup> 1999 (on the left), and at the end of 2001 (on the right); its prestressed concrete arch structure had 231 m and 180 m spans; in spite of numerous echo soundings, the exact position of arches lying on the riverbed is still unknown, but it is estimated that a 7 m high underwater sill has been formed along the entire cross section, radically affecting the flow pattern.

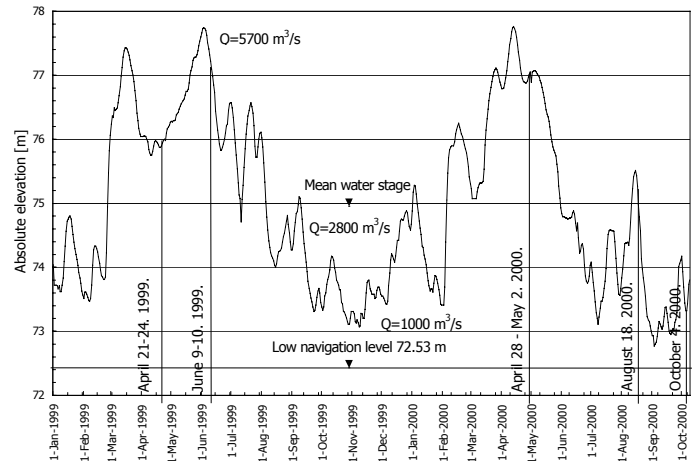
Fig. 4. Water stage hydrograph and dates of echo soundings

In April 1999, the destroyed bridges formed submerged barriers on the riverbed, thus causing large-scale scouring immediately downstream from each bridge. The evolution of the riverbed was registered in several echo sounding campaigns, undertaken from April 1999 (immediately after bombing), to September 2001. Fig. 4 shows the hydrologic regime during the period of the most intensive riverbed morphological changes, one year after the onset of the scouring process.

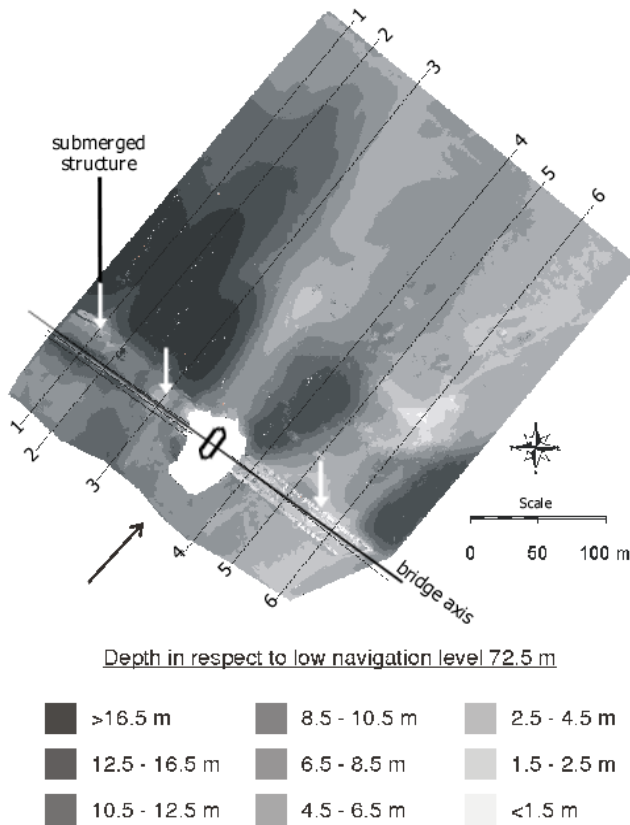
Fig. 6 Plain view of the scour pattern two years after the beginning of the process (on the left), and axonometric view of the longitudinal profiles (on the right); measurements were performed using multibeam echo sounder with approximately 9 points per square meter (Courtesy of Barthel & Sohn GmbH, Germany)

Three large scour holes formed downstream from this bridge (cross section (3) in Fig. 5, Fig. 6). Their size is affected by a number of superimposed factors, such as: hydrologic regime, geometry of the sill, flow conditions, secondary effects of curvature, etc.

The most recent and accurate scour pattern is shown in Fig. 6. The hole has reached its ultimate depth, all of the alluvial material - sand and gravel, has been washed away and the clay stratum has been reached; however, minor downstream translatory movement of the hole is still observed.

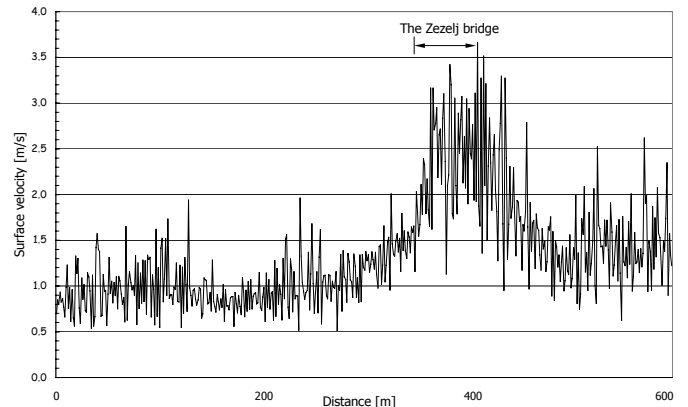
Fig. 7 Surface velocities measured along the longitudinal axis of the principal scour hole downstream from the fallen Zezelj bridge (Oct. 1999).

disturbed as well, the submerged bridge structures having induced accelerated flow zones (Fig. 7).

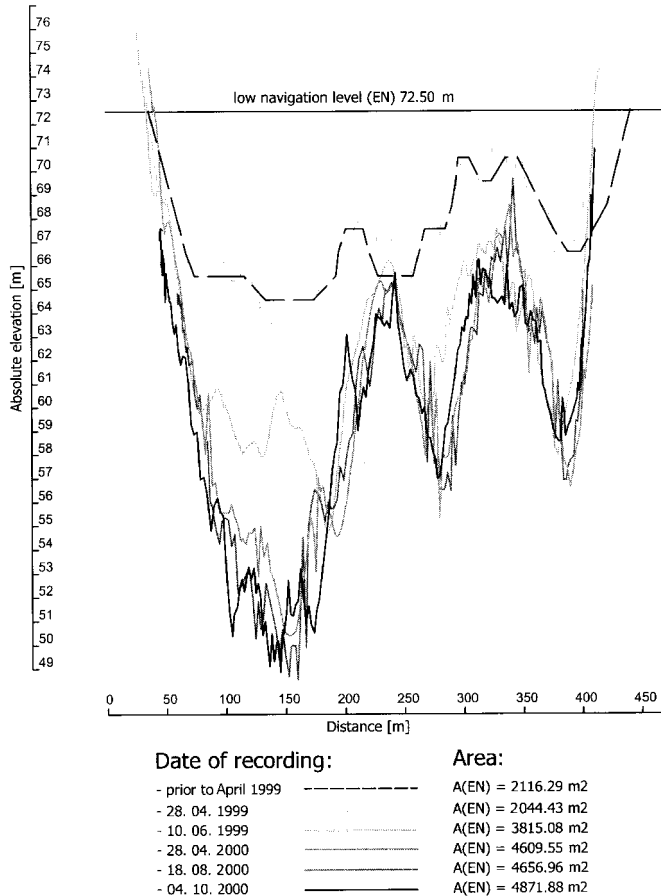
Fig. 8 The evolution of a cross section immediately downstream from the Zezelj bridge (km 1254.090).

An attempt is made to quantify the scouring phenomenon. Fig. 8 shows the evolution of a cross section located 80 m downstream from the Zezelj bridge axis, with three distinct scouring holes.
